THE
GREAT EARTHQUAKE
OF JAPAN

1891.

BY
JOHN MILNE.
AND
W.K. BURTON.
PLATES BY K. OGAWA.

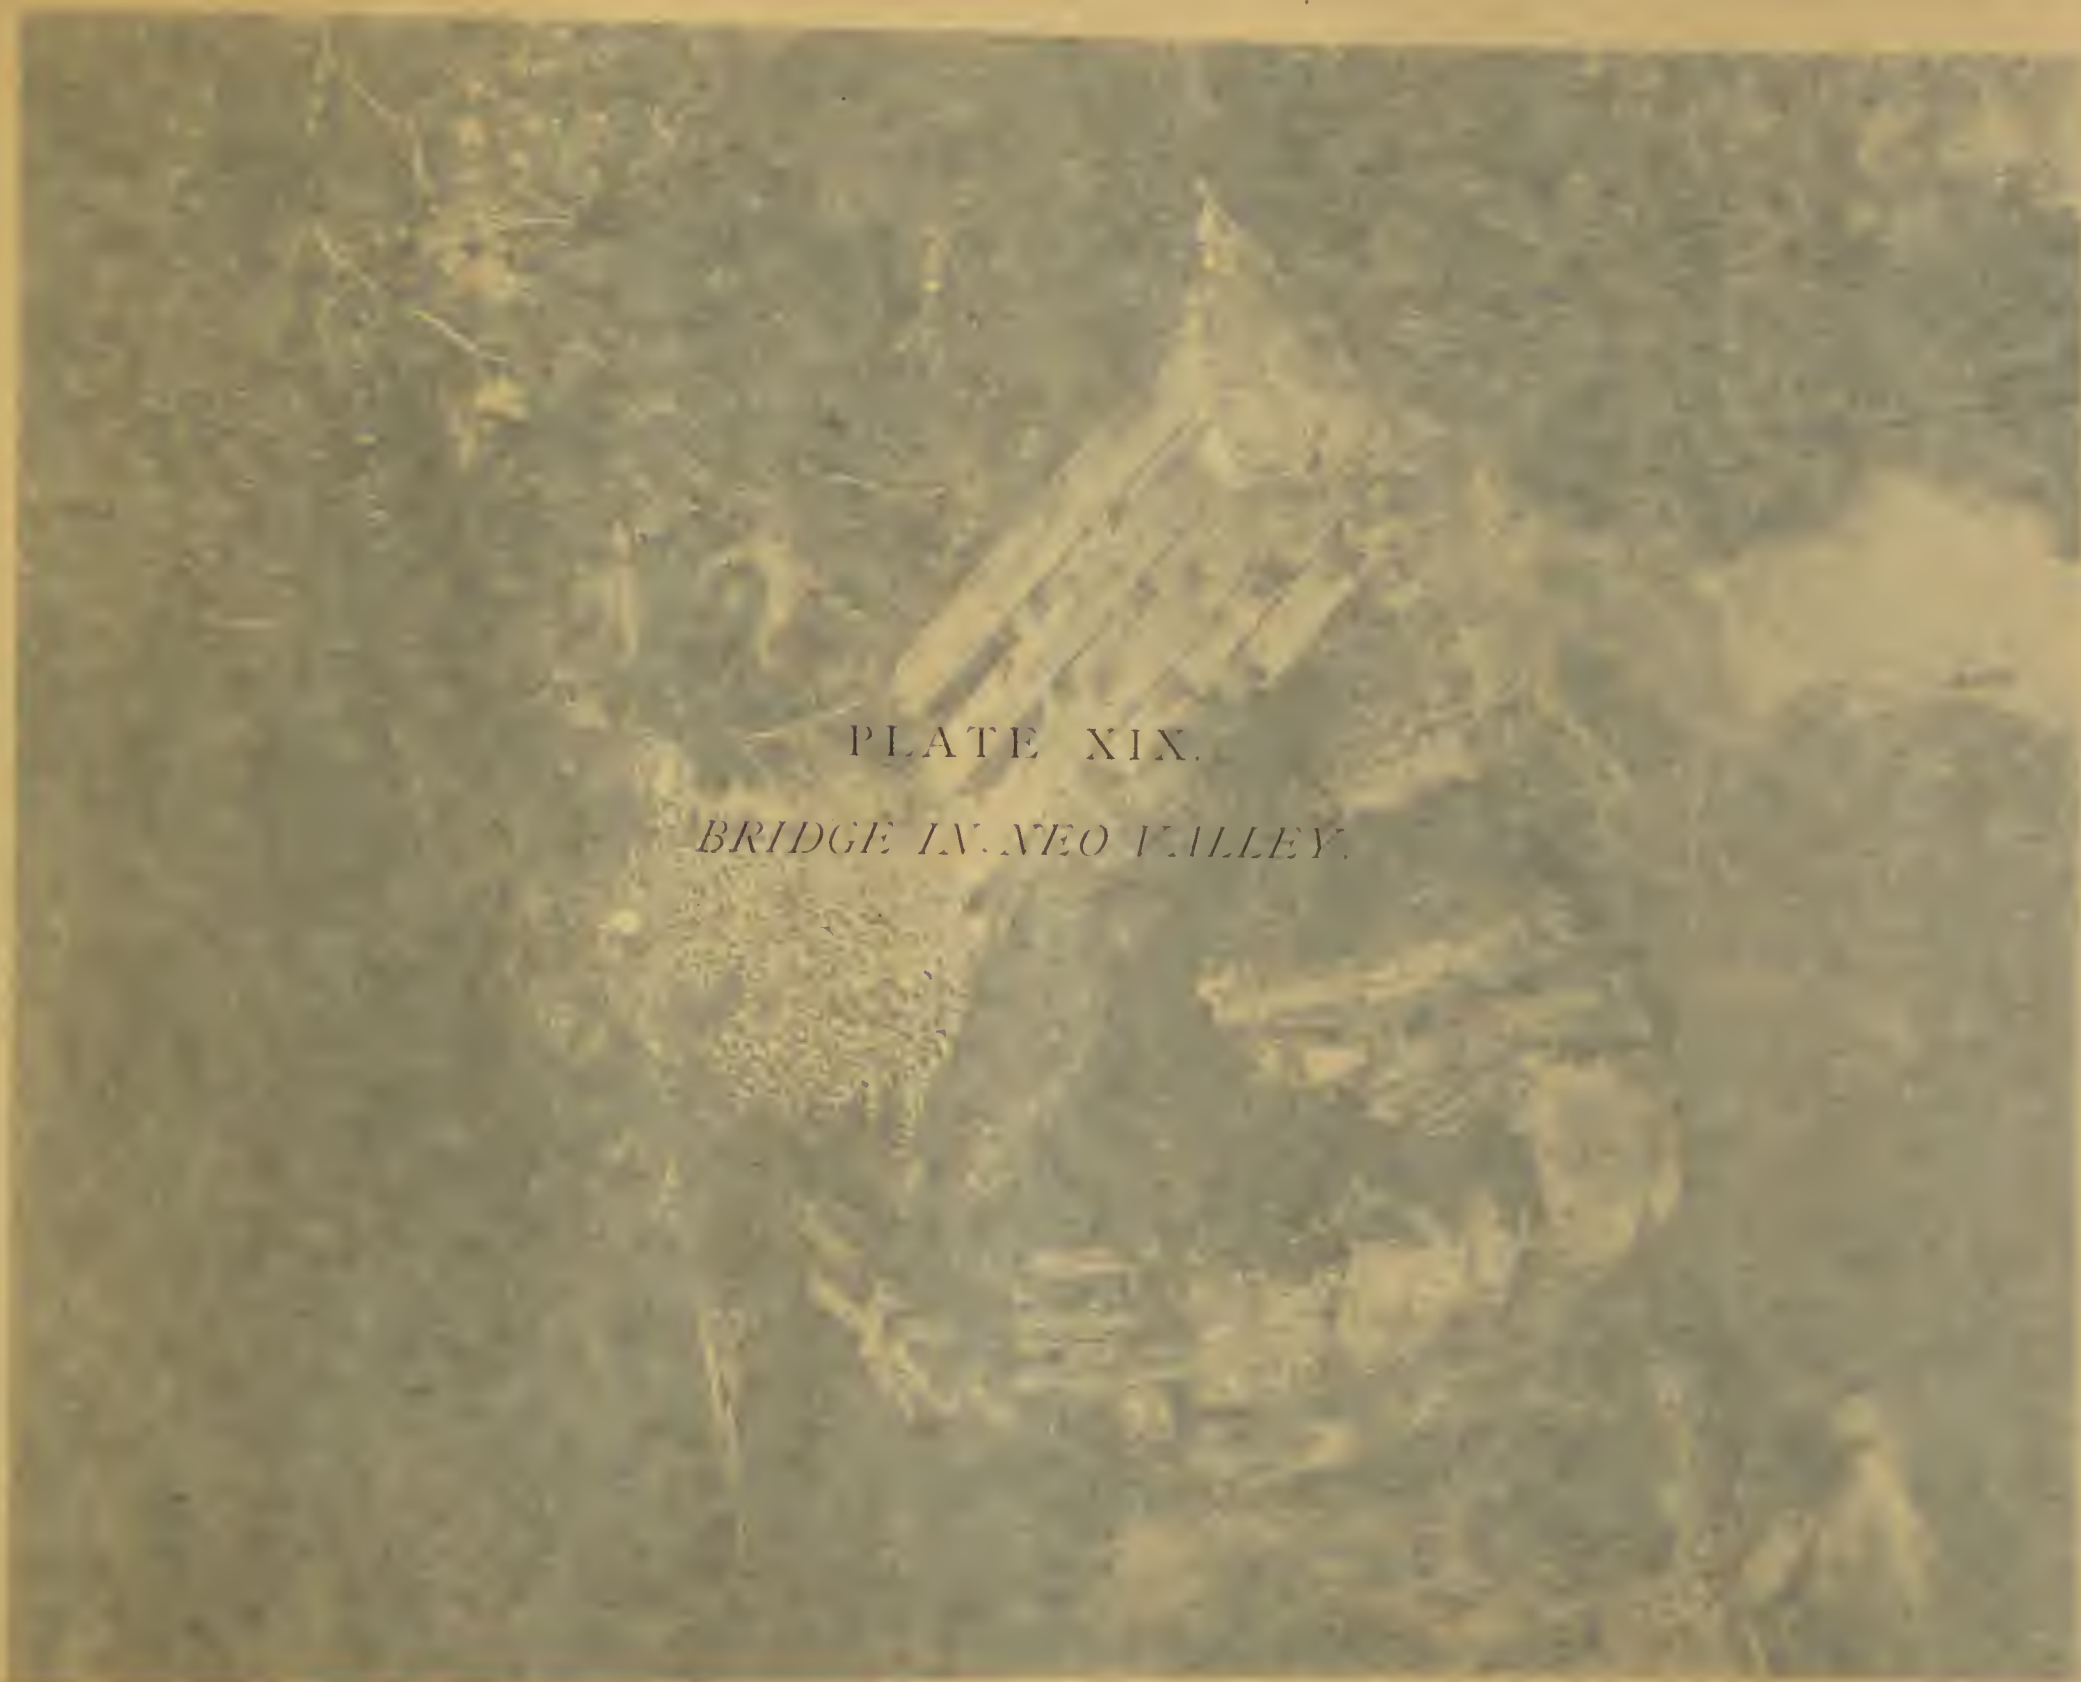
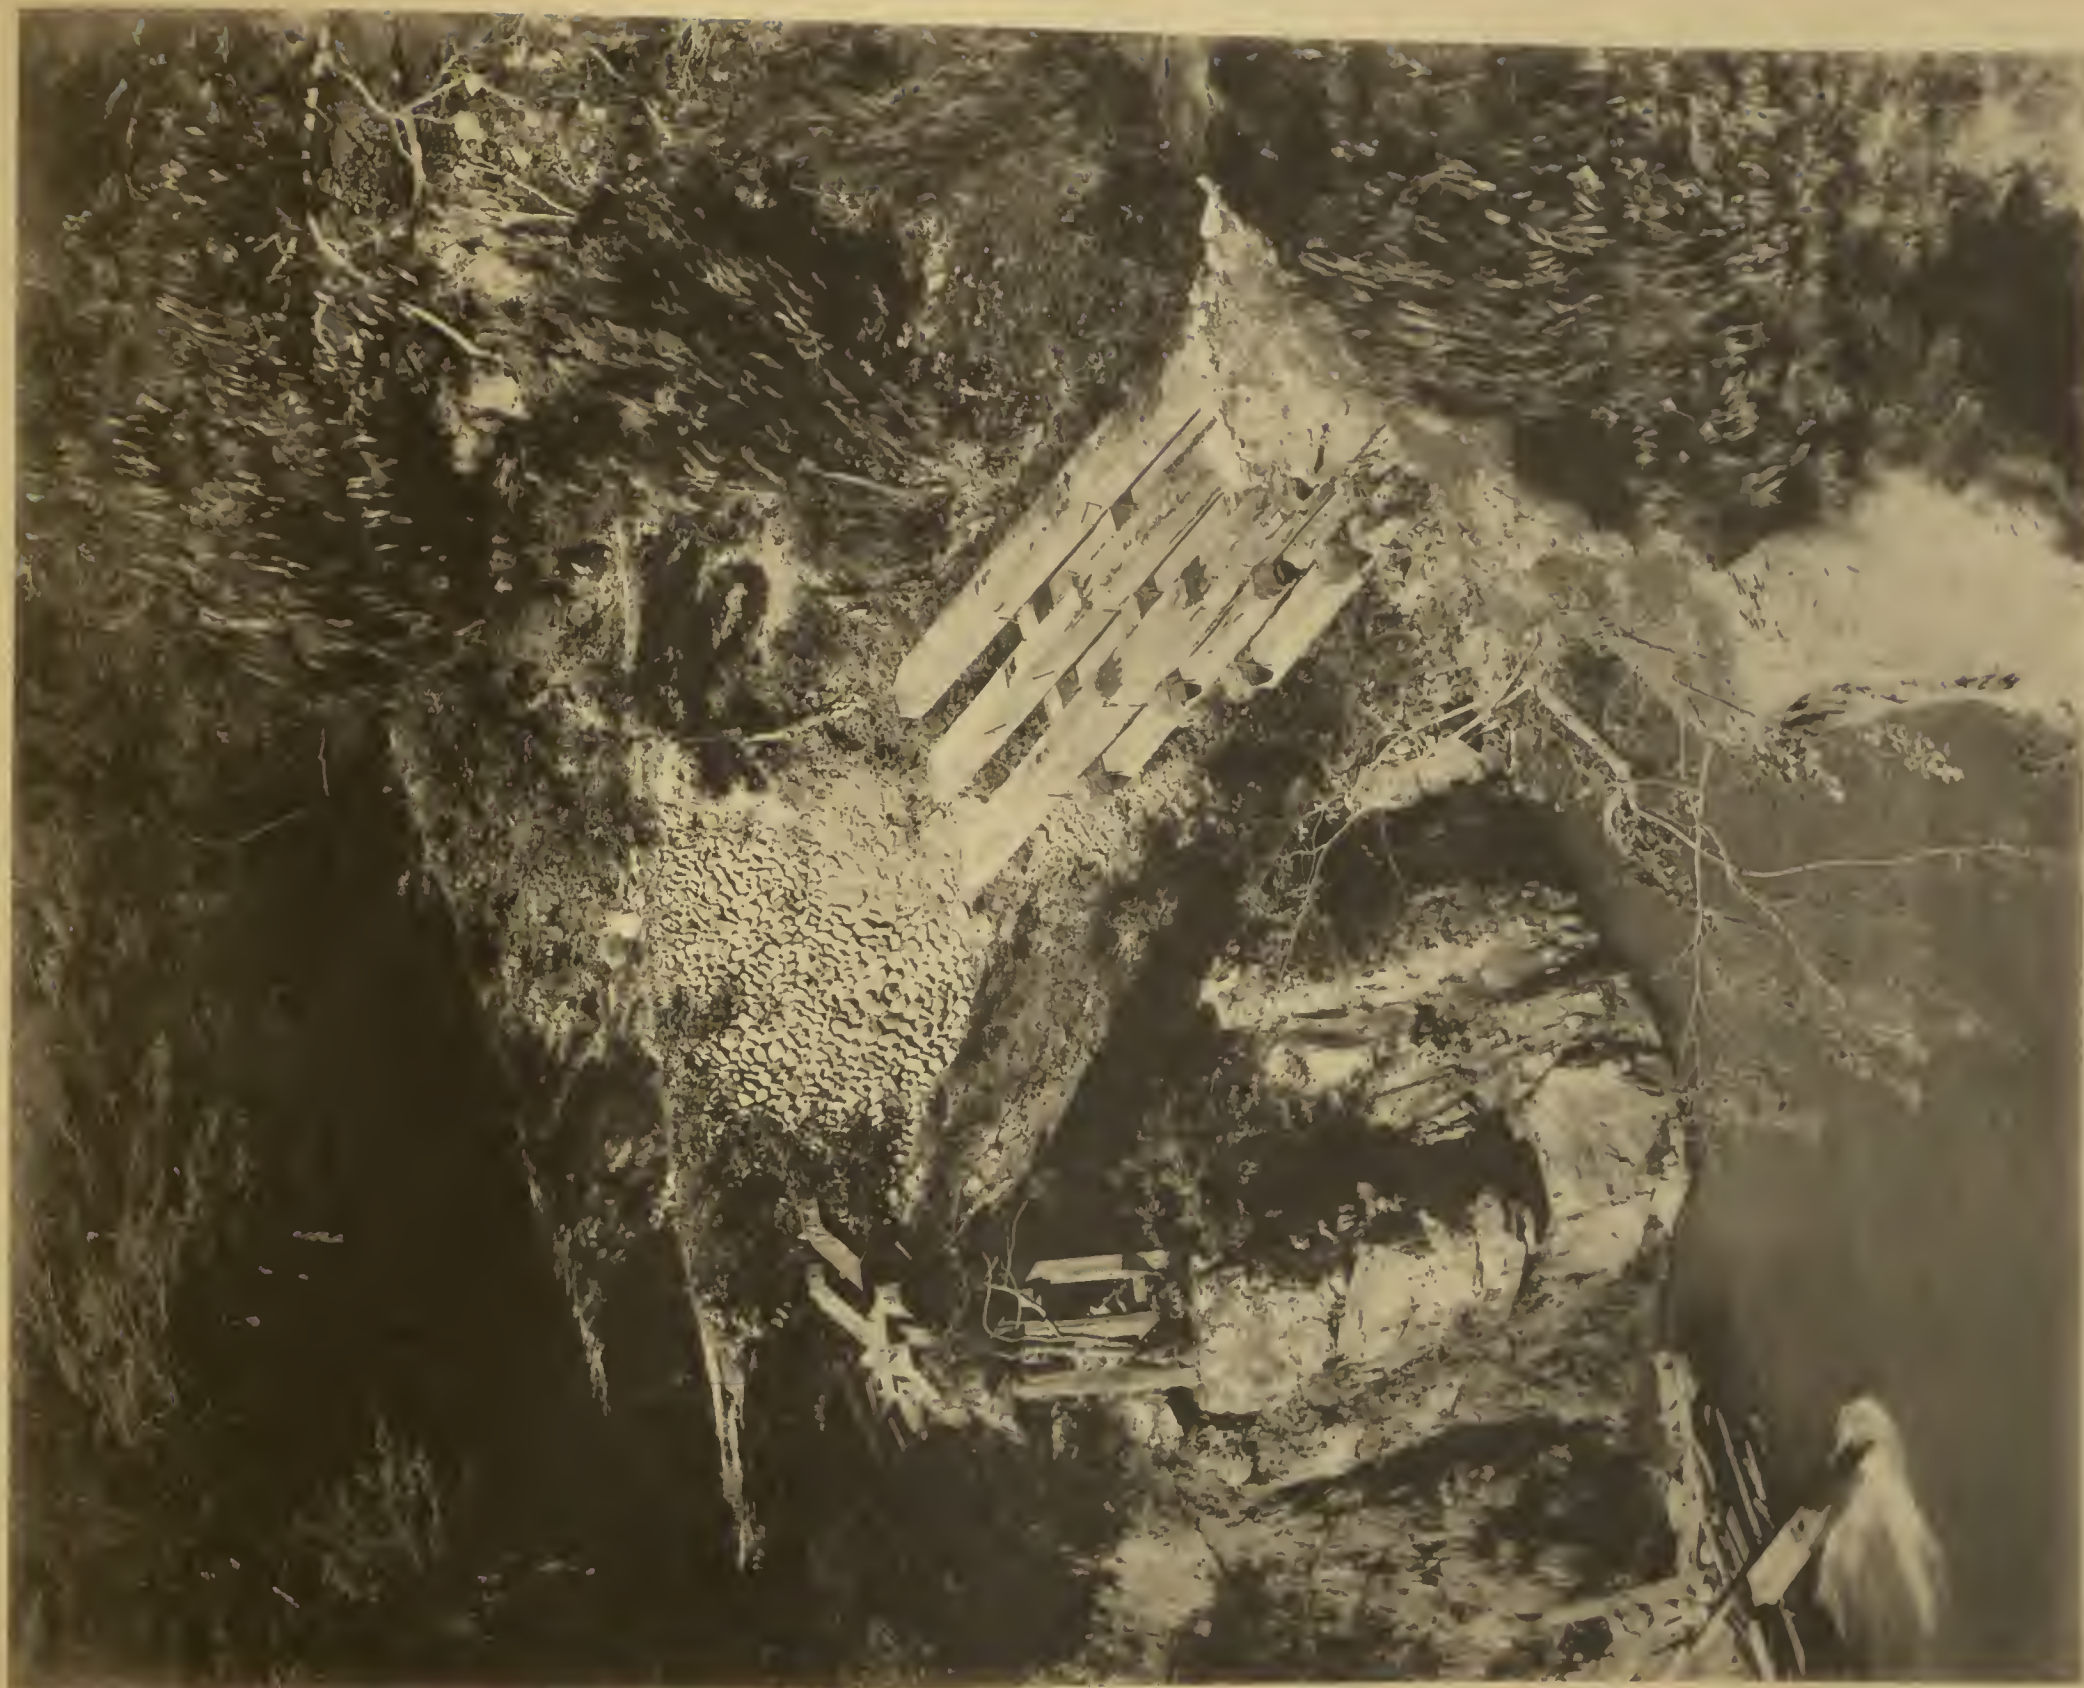
PLATE XIX.

BRIDGE IN NEO VALLEY.

BOUT five miles above Hinata we met with an unexpected obstacle. The river here had to be crossed but the centre of the cantilever bridge had been totally destroyed by the Earthquakes, and on account of the rain, the river was not fordable. One little bit of the central span is seen in the left hand corner of the picture. It is remarkable that the forces which had destroyed the bridge had failed to disintegrate the rubble wall supporting the pathway on the opposite bank of the stream.

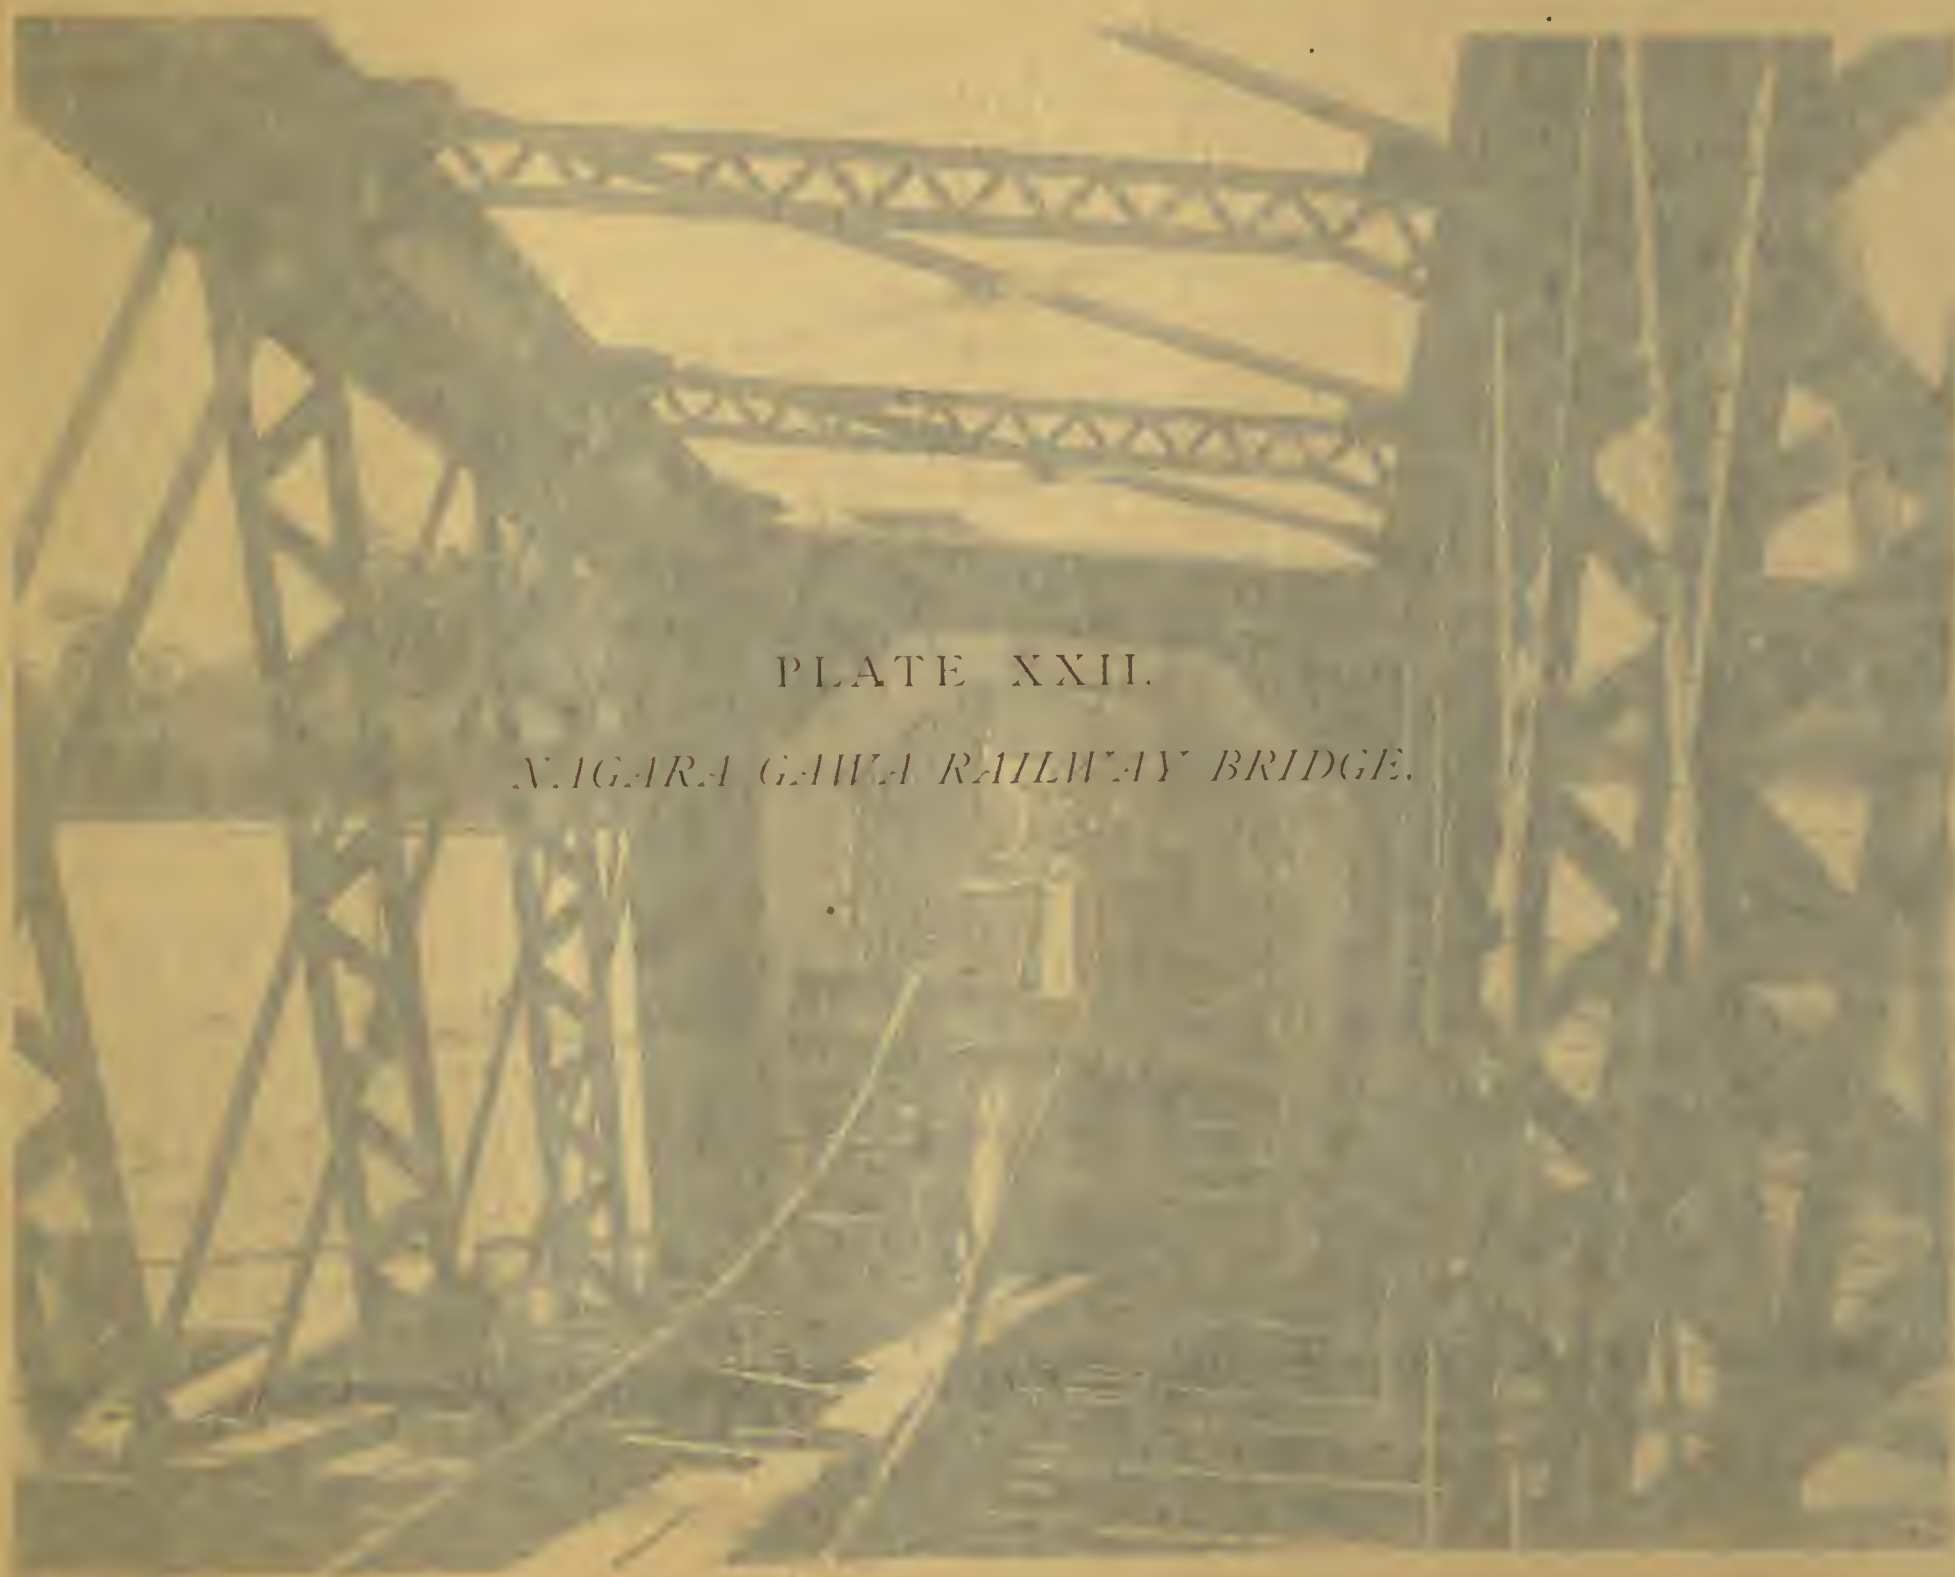
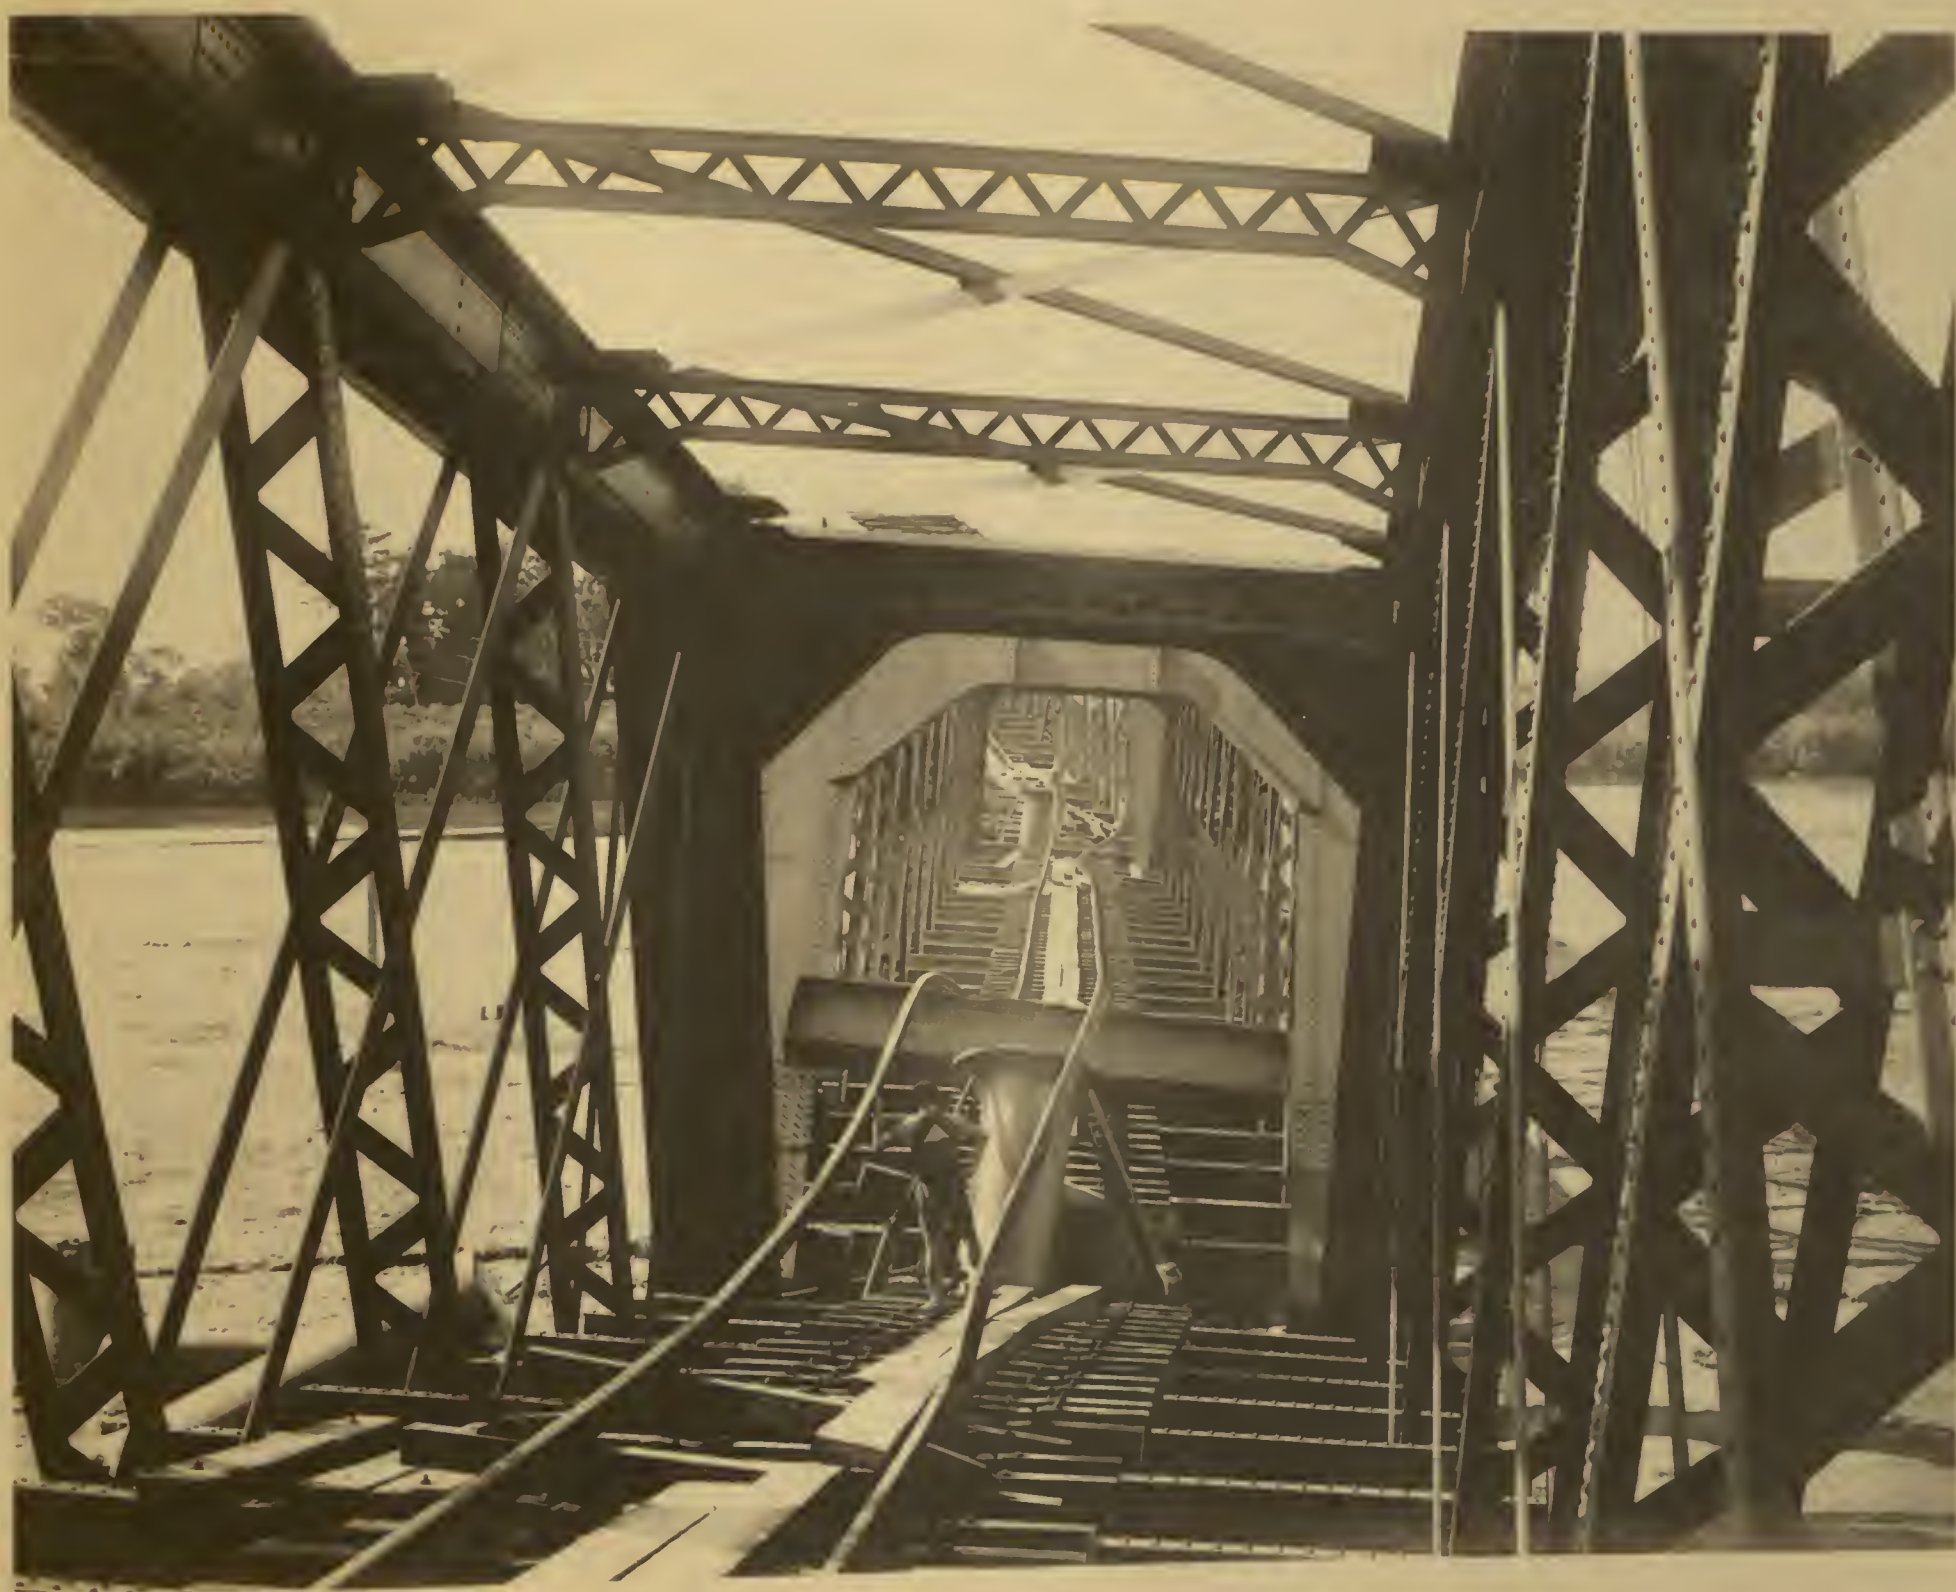
PLATE XXII.

N this picture we see the broken cast iron piers lying on the dry shingly bed of the river, like pieces of a huge carrot, and also that the original line of the bridge has, in its central part, been deflected up stream.

Although the cracks in the banks being parallel to the river, seem to indicate a movement, or the component of a movement, at right angles to their length, yet here, as at other bridges, it would appear that the movements, especially in the central parts of the river beds, have resulted in extensive permanent displacements, either up or down stream. Whether it is possible for engineers to build bridges which will resist such large bodily displacements as have been experienced along the bed of the Nagara and other rivers is a matter of question. Had the piers risen from a broader base, been made of wrought iron and had an Eifel tower like form, although they might not have been fractured, it is difficult to imagine that lateral shifting and bending would have been avoided.

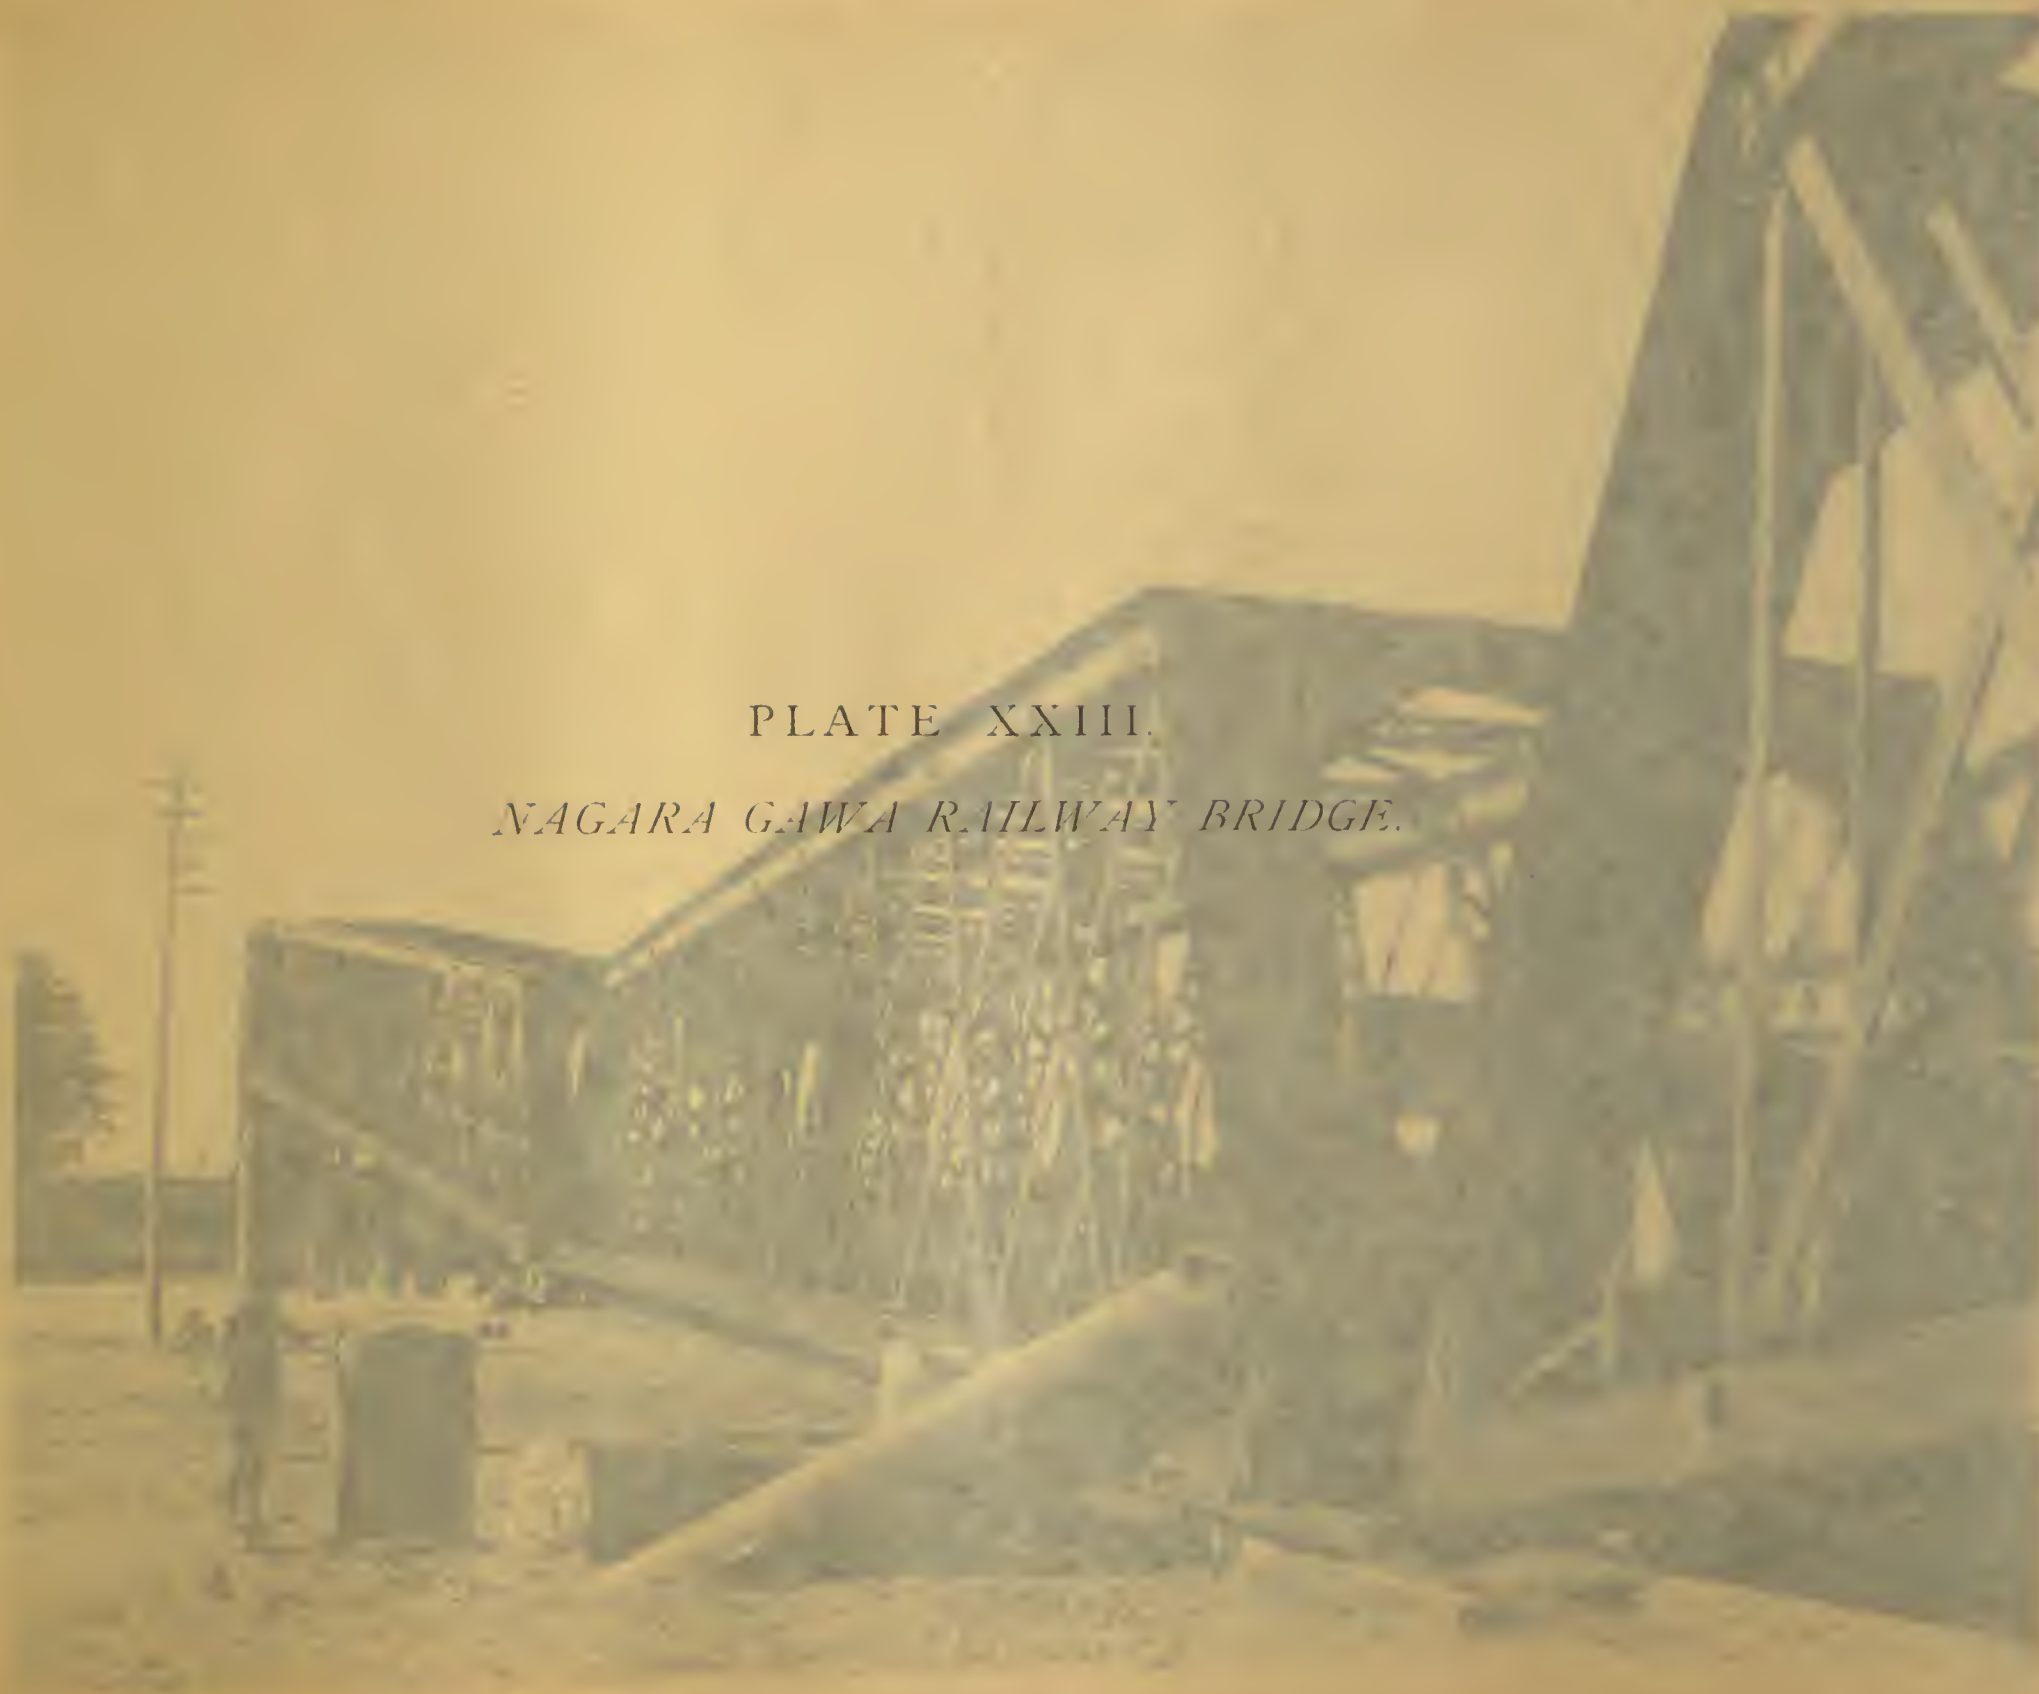
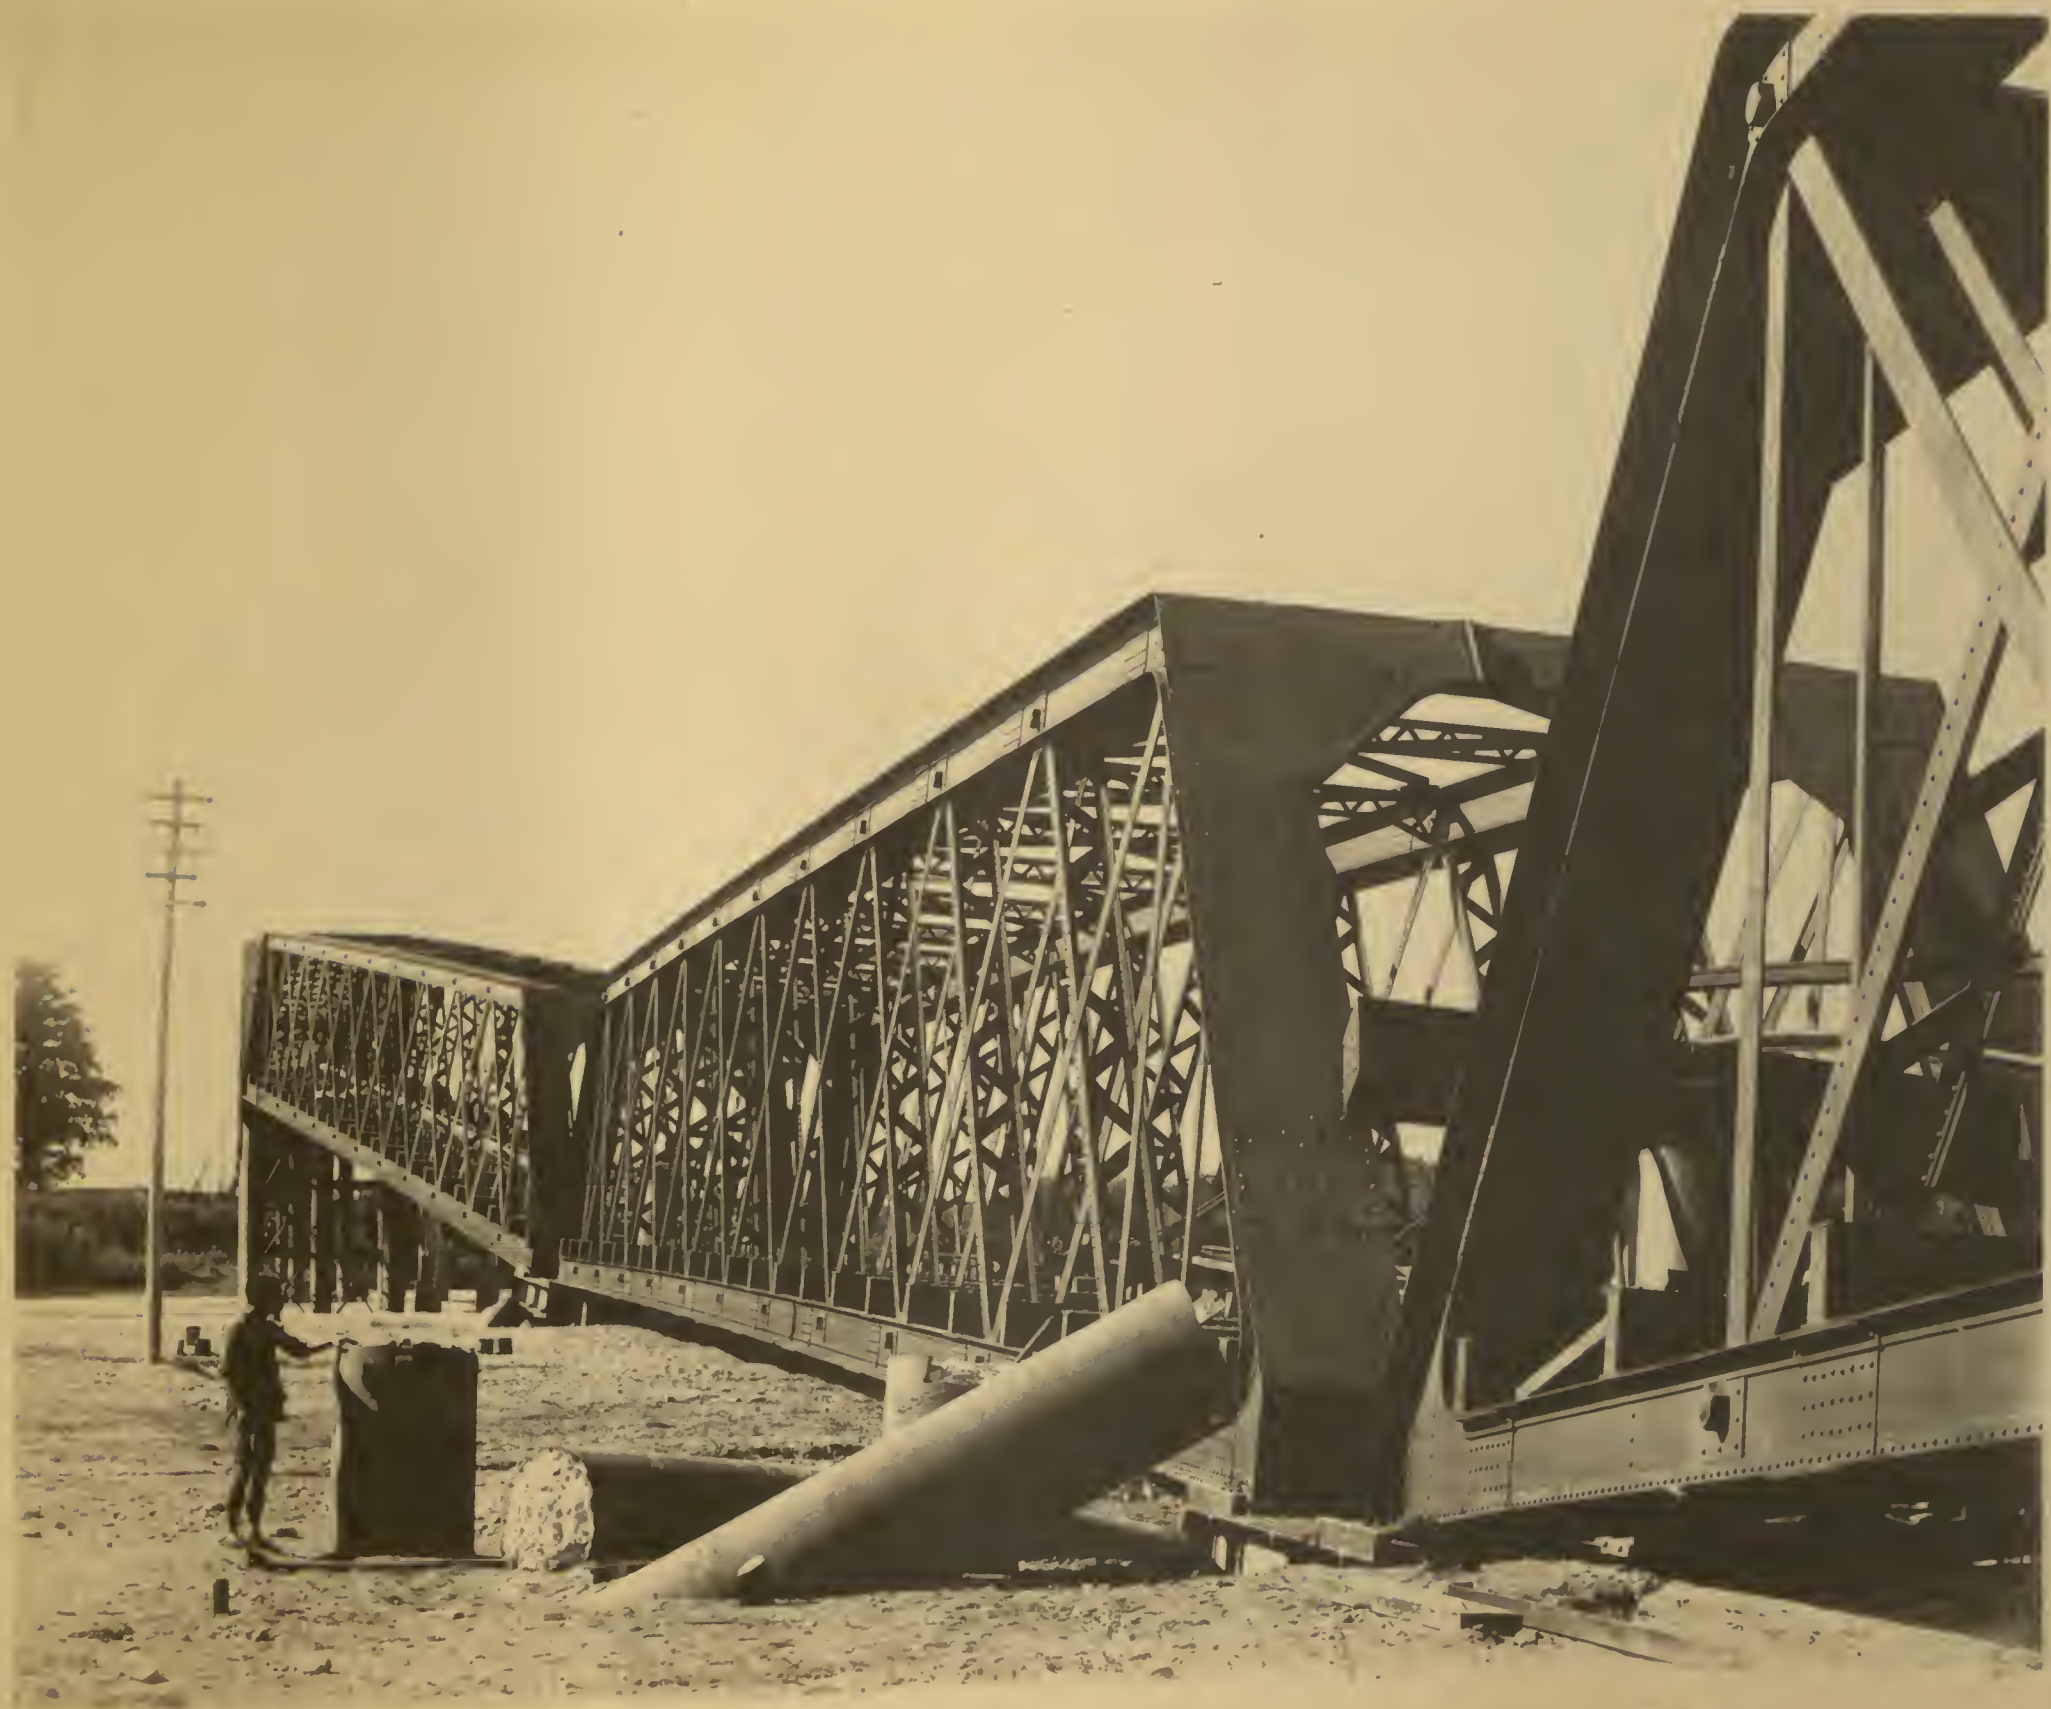
PLATE XXIII.

The cause of the collapse of this bridge is undoubtedly the failure of the piers. The girders, even those that have fallen, appear, on a casual inspection, to be straight and intact.

It will again be observed that the portion of the bridge which has fallen, relatively to the part which remains standing, has been thrown some distance out of a straight line.

Examination has shewn that this displacement, is not simply a displacement of the upper-work of the bridge, but the ground with the screw-pile foundations has been shifted a distance of several feet up the stream.
